MIPP TPC

Peter Barnes
Physics and Advanced Technology
Lawrence Livermore National Laboratory

Fermilab, 11 June2004

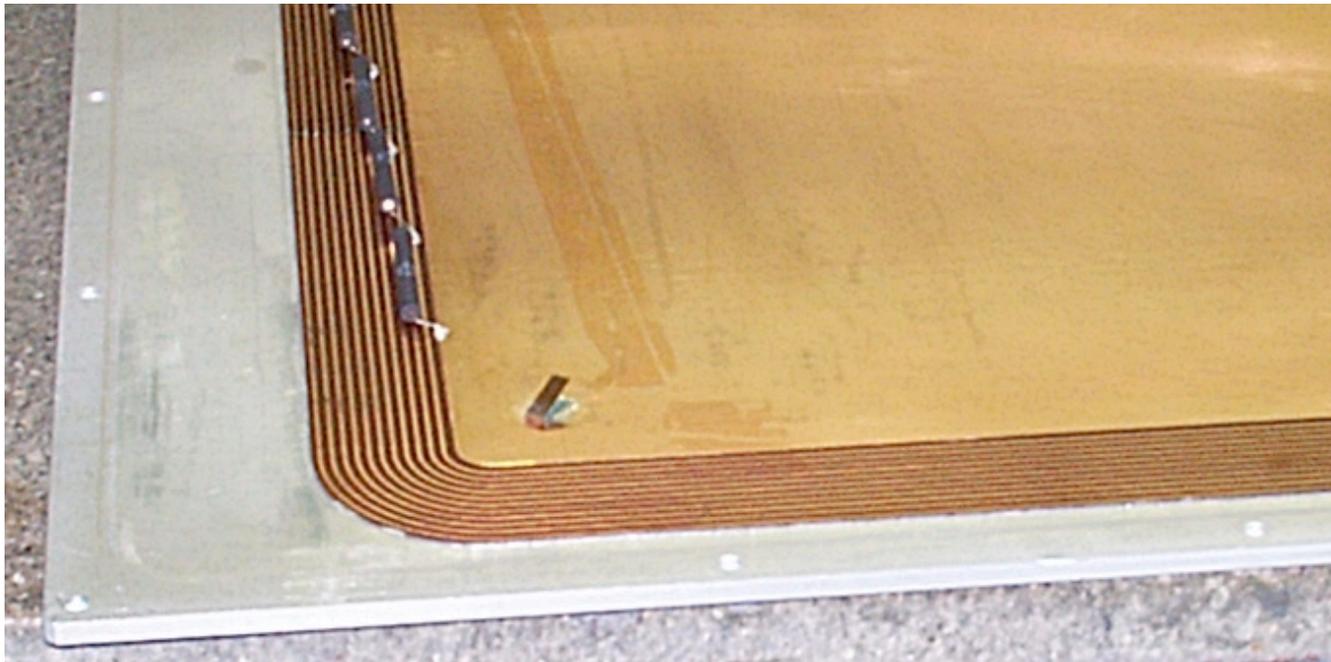
- Ramped to 10 kV in N₂ :)
- Ramped to 5.6 kV in P10 :(
 - Go back to N₂ and retest - today Done.
 - Open lid and inspect? Done.
 - Plastic window to locate arc visually? Done.

TPC lid resistor ladder repaired, cathode stable at 10 kV in P10.

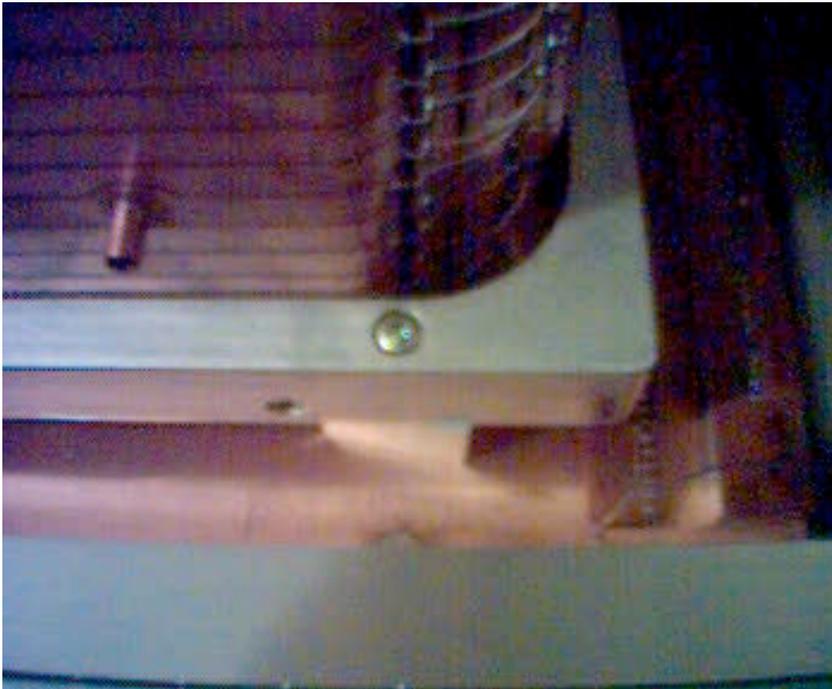
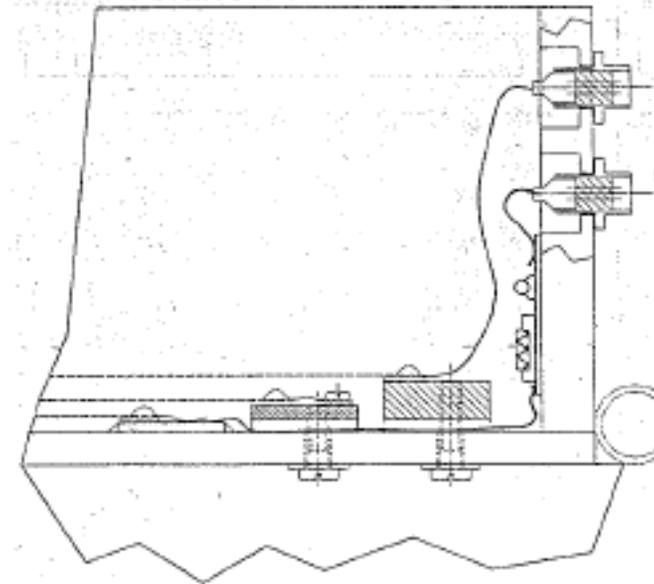
- **Gating Grid**
 - Fix pot knob, rack slide **Done**
 - Connect cables to TPC **Done**
 - Test operation (waveforms on scope) **Finally done**
 - **First had to find, fix all the ground faults**
 - **2 of 4 Field Cage support blocks had rotated to touch end gating grid wires**

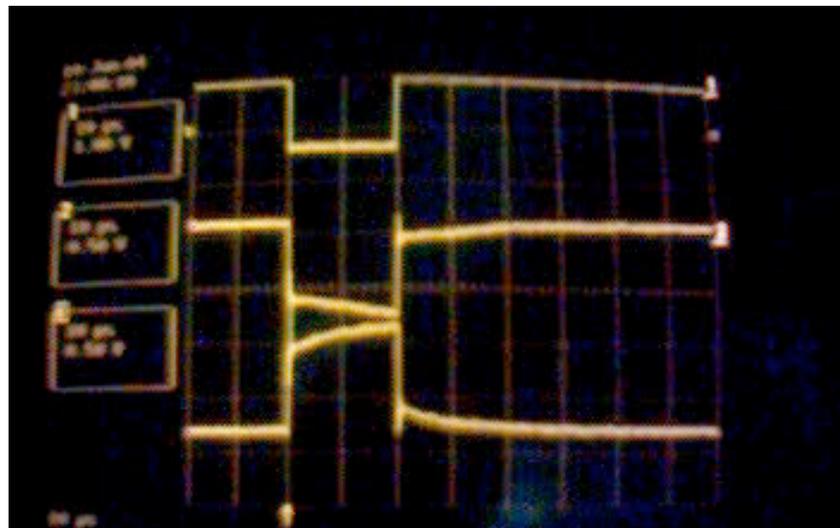
Top	Gate
Middle	“Positive” Grid
Bottom	“Negative” Grid

Monitor outputs are distorted; real pulses have 100 ns time constants.

- Rebuilt all four cables correctly to remove ground faults
- Built terminator boxes for cables ends at TPC
 - Eliminated ringing!

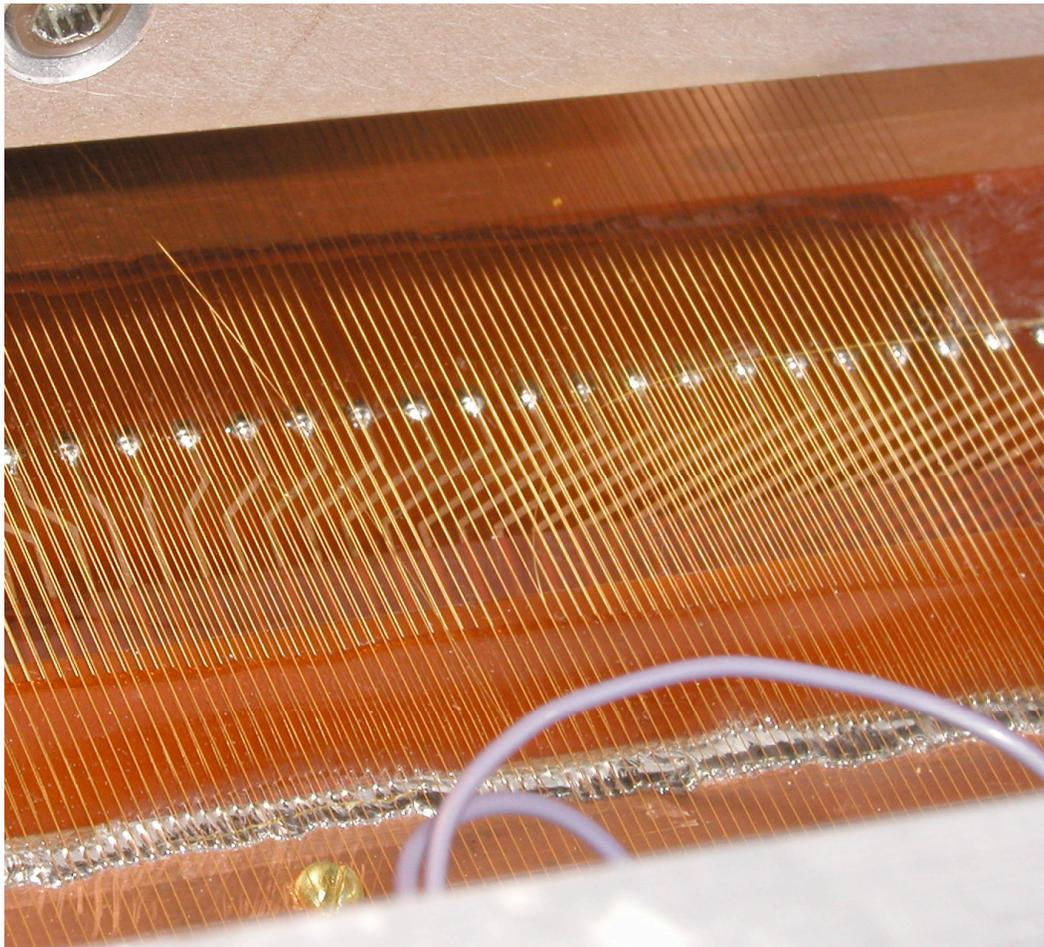
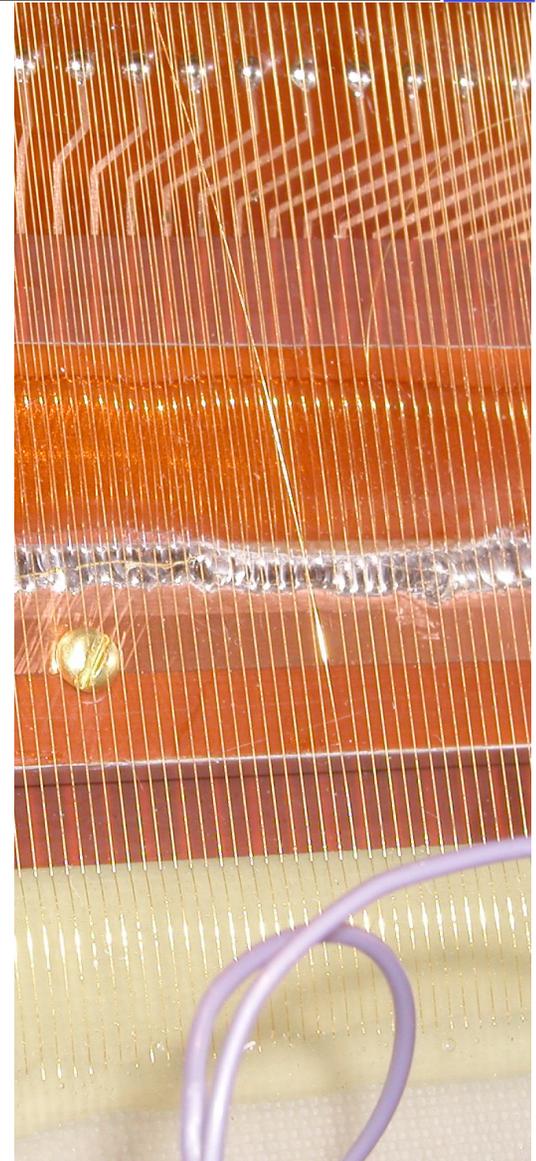
Inside on Memorial Day – 3 Broken Wires

- Going Left - GG
- Going Right - GND

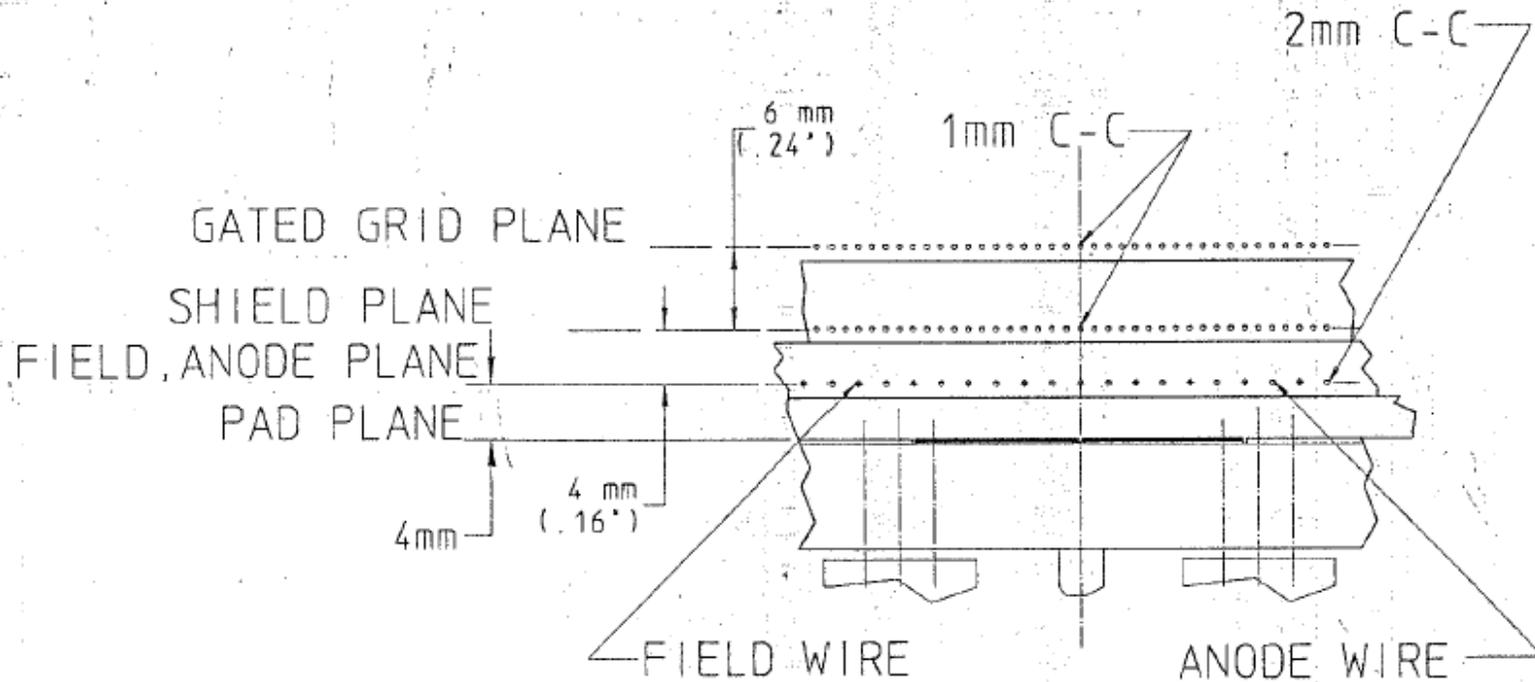
Wire Geometry

- **Note there are 3 anode sense wires per 12 mm pad row.**
- **Typical charge sharing is 3 pad rows.**
