Wafer level Testing of ASICs for Silicon Strip Detectors

Ray Yarema, William Wester
Fermi National Accelerator Laboratory

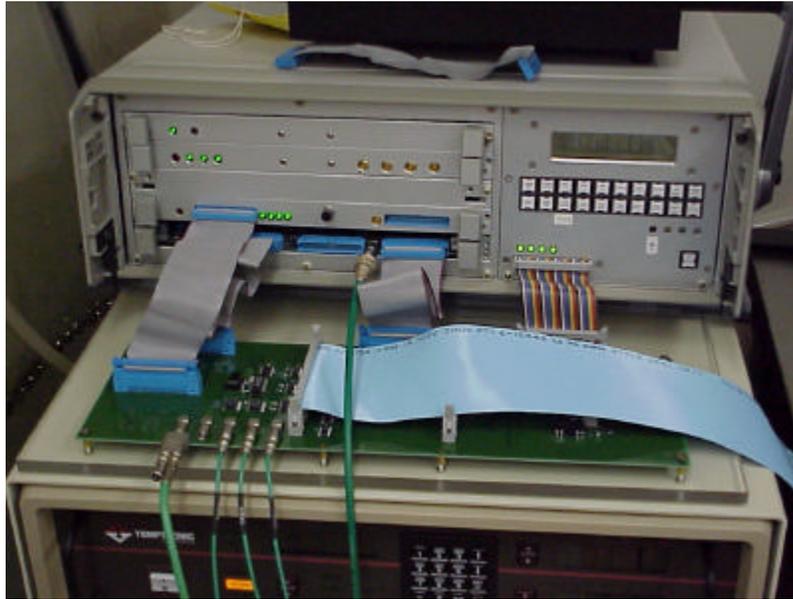
Test and data acquisition package.
Computer not shown.

Wafer level testing requires an automated probe station and a custom probe card along with an automated test/data acquisition system. The entire system is under computer control. The above photos show the automated data acquisition package and the probe station used for 2 of the chips at Fermilab. A similar system was used at LBNL to test the third chip.

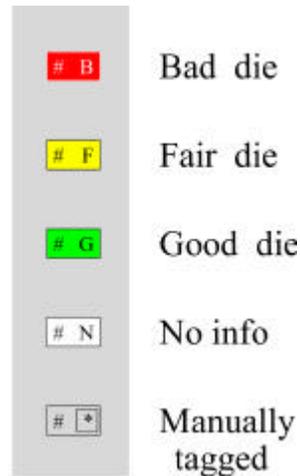
Typical SVX3 Wafer Plots from an Acceptable 4" and 6" Wafer

Lot 6 wafer 12

Lot 8 wafer 8

- Number on the wafer indicates die location
- Green = all channels good, yellow = 1 bad channel, red = more than 1 bad channel.

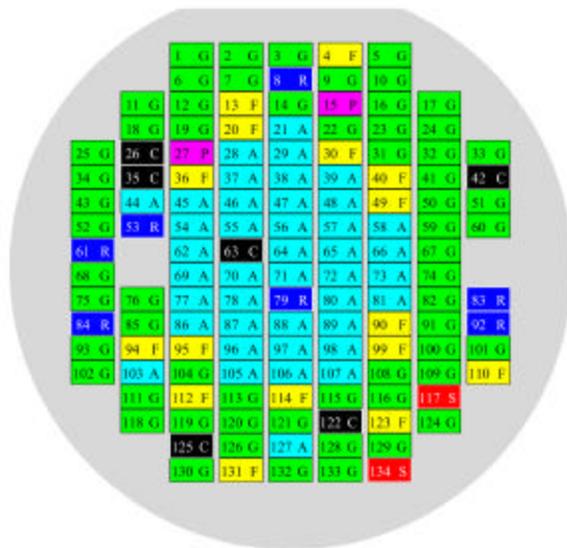
Lot 9 wafer 14

- Lots 9 and 12 showed yield “holes” in the middle of the wafers due to out of tolerance pedestals from the pipeline (as shown on left).
- Lots 10 and 11 show out of tolerance pedestals over the entire wafer and in some cases serial shift register failures in the middle (on right).
- The failure mechanism is the same in both cases.
