MIPP TPC Status

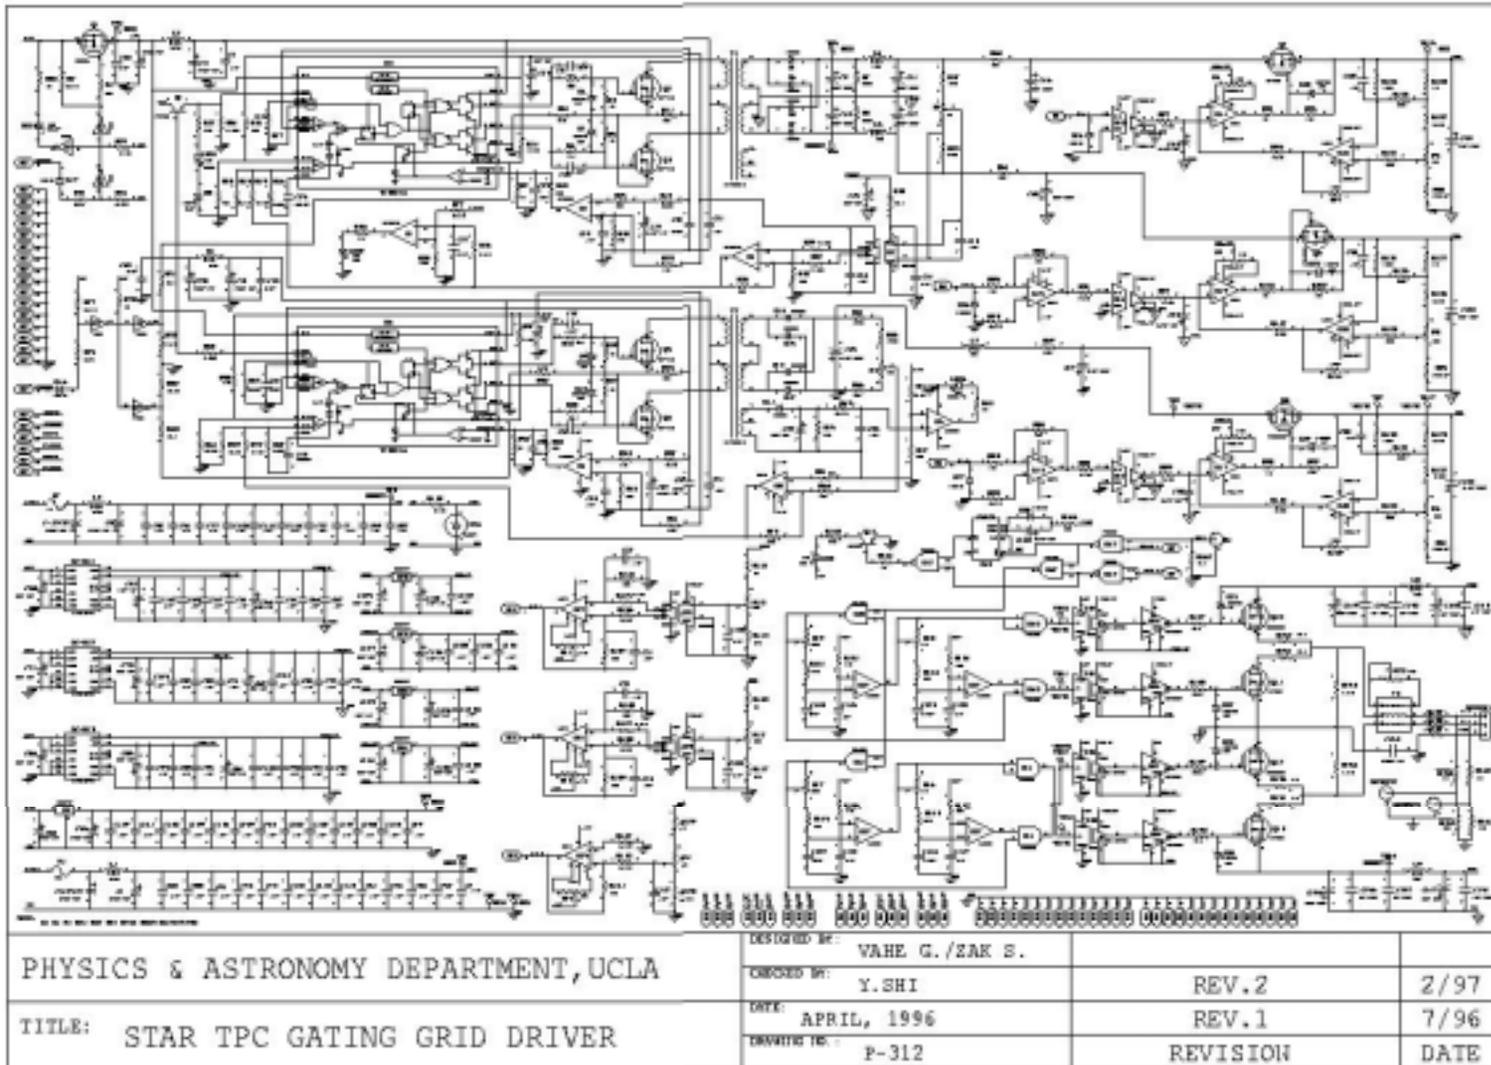
Who will help make the ... TPC Gating Grid
